# Feasibility & Space Needs Study Police and Fire Facilities Portsmouth, RI

**MAY 18, 2015**

## 1.0 SPACE NEEDS ANALYSIS AND ASSESSMENT: POLICE DEPARTMENT

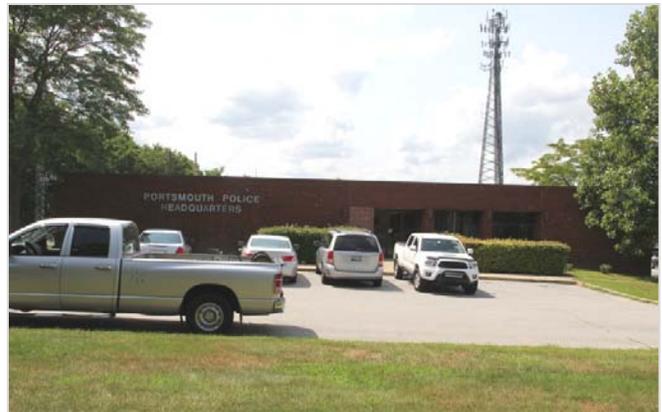
*Limited Parking for Visitors' Vehicles*

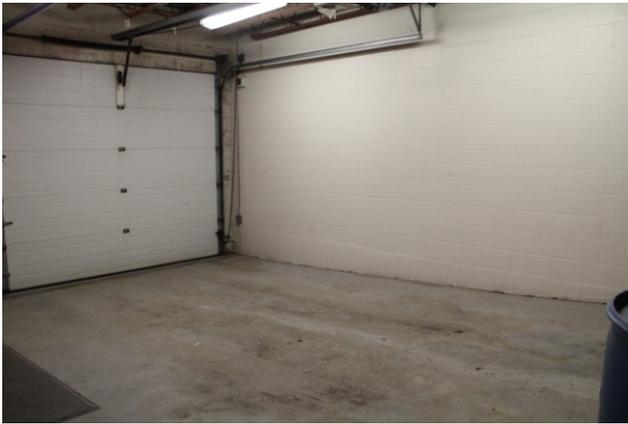
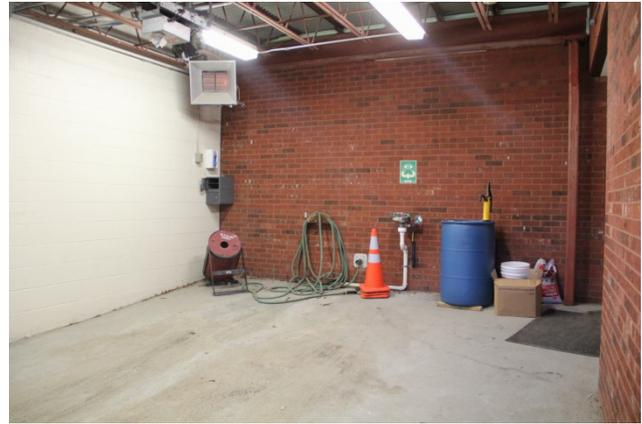
- The drive-in prisoner discharge (i.e. – "sally port") has a fairly steep slope on the floor. This condition could lead to an unsafe situation from car doors accidentally closing to slipping on the floor when trying to complete a transfer of a prisoner from vehicle into the building. (Photo 1)

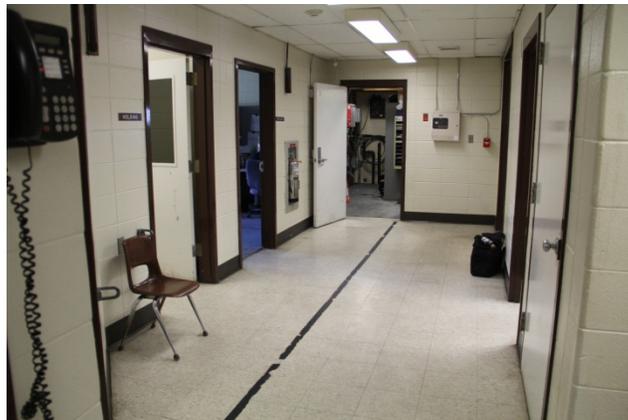
- Prisoners entering from the Sally Port must share public areas (connecting corridors) to access the Booking and Interview Rooms. This requires the temporary securement of the corridors and Dispatch Room until the prisoner has been brought into the Interview area. This arrangement can lead to further confrontations or a breach of security if a person in the Corridors or Patrol Room is associated with the prisoner being arrested. It may also disrupt the flow of normal business activities and the efficiency of operations for the dispatcher/receptionist.

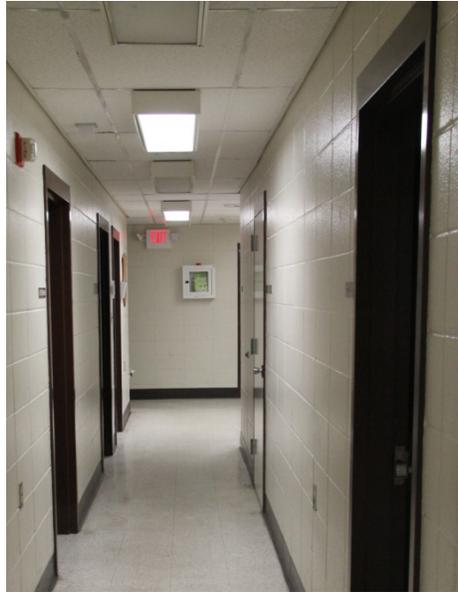
- Prisoners located in the Detention Cells off the Interview Room share the same corridor serving other functions and pass public areas where civilian employees and others are present in order to get to the Interview Room. This not only endangers uninvolved people but also increases the risk of prisoners obtaining and using available weapons.

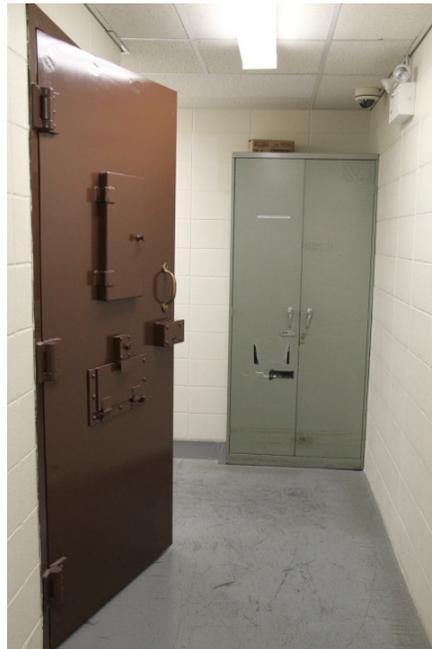
- Within the Detention Area, there is a storage cabinet due to a lack of space in this building. This could be a potential safety issue if an unruly prisoner gained access to its contents or could severely vandalize the cabinet.

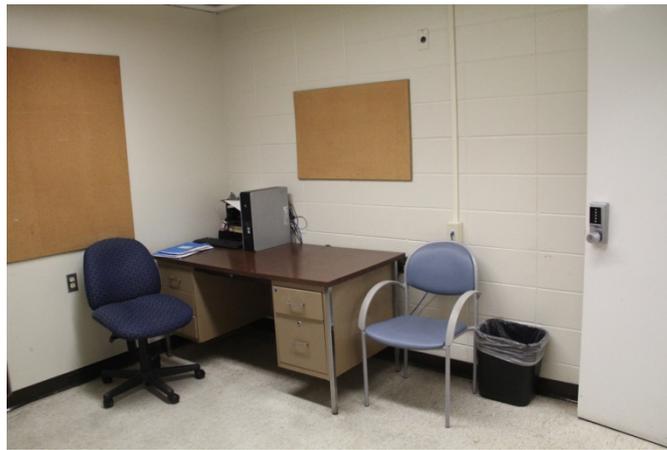
- Administrative staff must pass by the interview room and detention cell subjects them to potential verbal and visual abuse when passing by these areas.

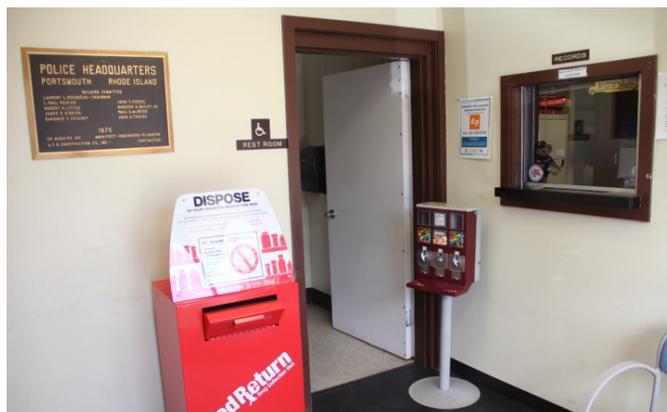
- Victim safety is inadequate – one often must wait alone in the small public lobby until an officer or interview room is available to provide testimony or lodge a complaint.

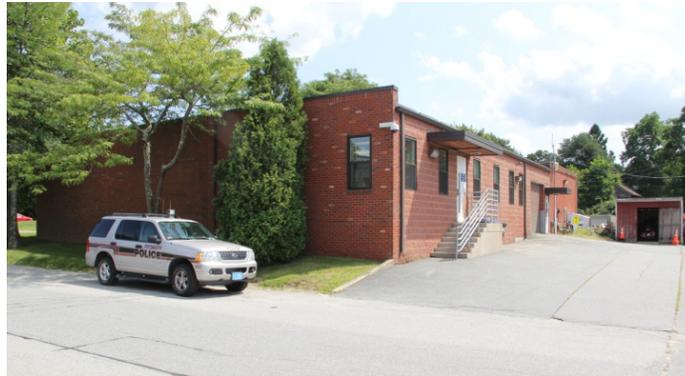
- Police vehicles are not located in a separated area from public access while parked and may be subject to occasional vandalism with the potential for worse situations. This could be dangerous or disastrous to the officers who may not discover the damage prior to driving the vehicle away. This also represents a large investment of the taxpayer’s money.

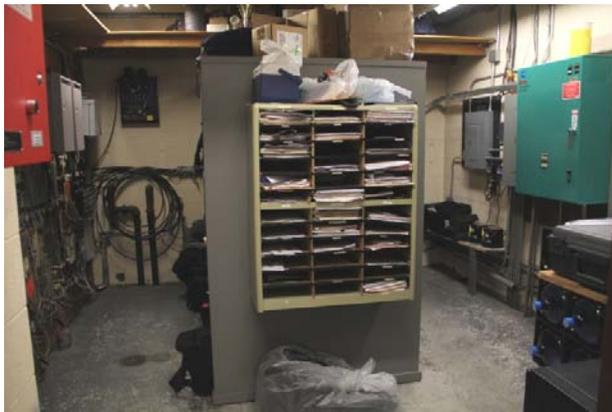
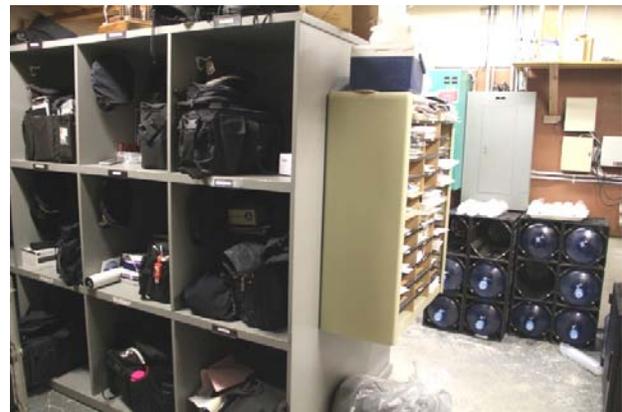
- Many areas of the Police Department are not secured with modern devices or equipment. This allows the potential to have vandalism, theft and the shutting down or compromise of services to occur. Areas such as the telephone and radio equipment room off the corridor serving the Sally Port where telephone, communications and electrical equipment are accessible, are not well secured and can be severely damaged within minutes with little or no chance of stopping such an occurrence. This Utility Room is shared by the police personnel, mailboxes, gear and miscellaneous storage, thus is wide open to the public.

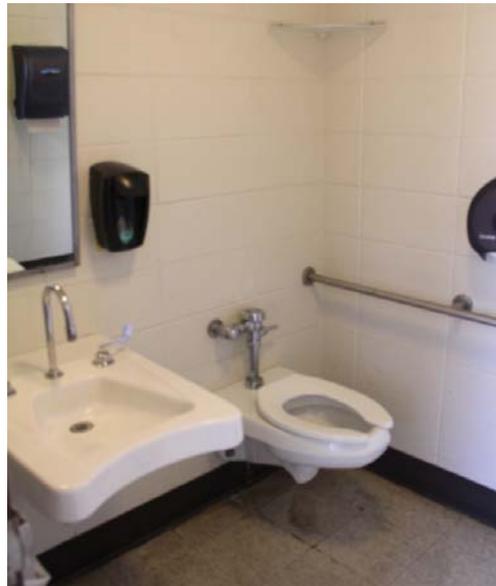
- Many areas are unmonitored and easily accessible. Important areas such as evidence storage and police records could be easily compromised and/or destroyed without being discovered in a timely manner. Windows to the exterior are points of entry where security can be breached.
- Restrooms are not separate and private for witnesses, victims or employees. This is potentially dangerous when being shared simultaneously with suspects, angry family members and other opposing persons.

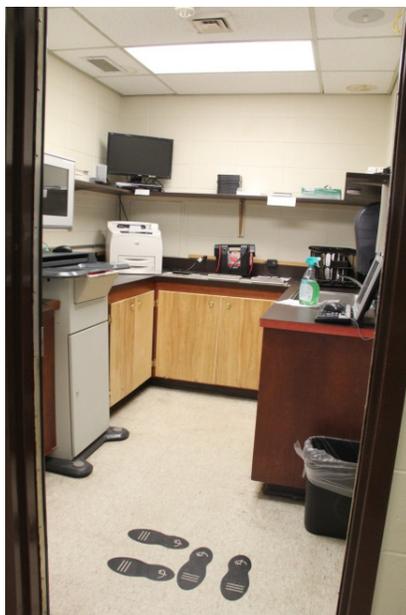
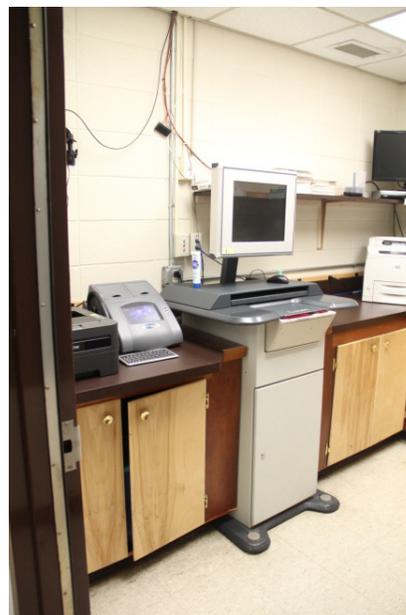
- Prisoner processing area (booking) is not located in a “secure” portion of the building and is subject to visual and audible contact with members of the staff passing through the adjacent corridor.

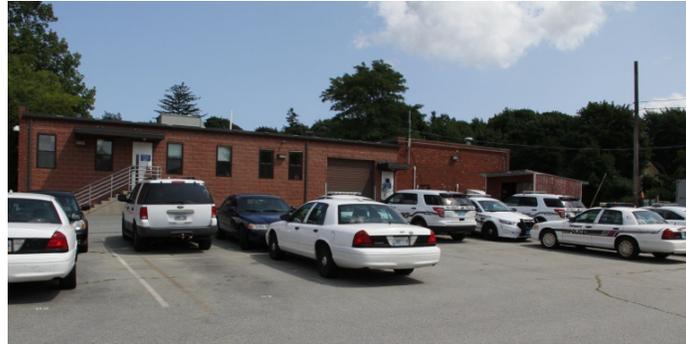
- Private parking of employee’s vehicles – police employees are often the focus of angry suspects looking for a way to get back at the establishment which has focused on them. The potential for vandalism or tampering with private vehicles is great when unmonitored, especially at night, in the back or side parking lots. This also pertains to the lack of safe designated separate parking for victims, witnesses and the public.

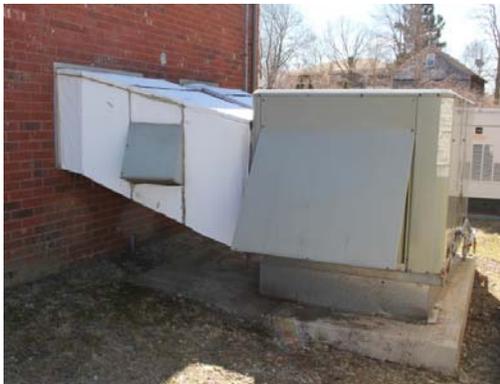
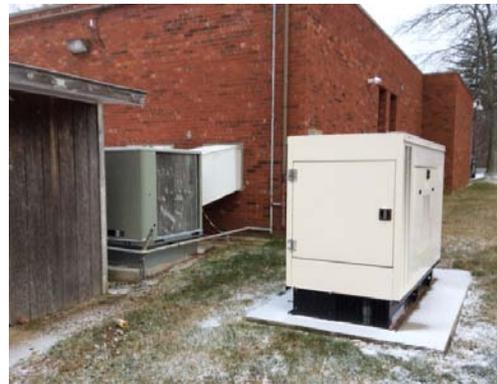
- Exterior HVAC unit, emergency generator and radio tower are not located inside a locked, fenced-in area. These could be subject to vandalism or intentional damage so as to disrupt police functions and cause security breaches.

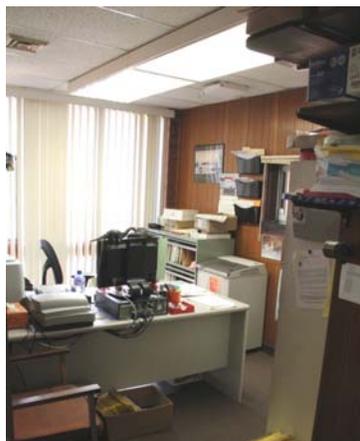
- The unprotected service window in Records/Administration appears to be located in a wall with little or no ballistics resistance. This can lead to injury to personnel, damage to sensitive equipment, and a breach of security. Accomplices to a crime could gain access, force an employee to disable security systems and set free those being processed or being detained.

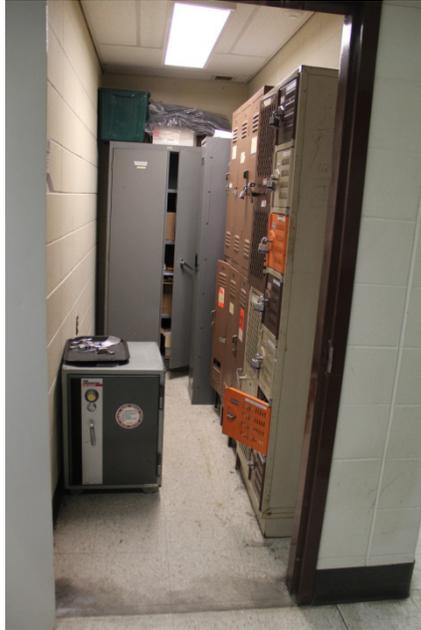
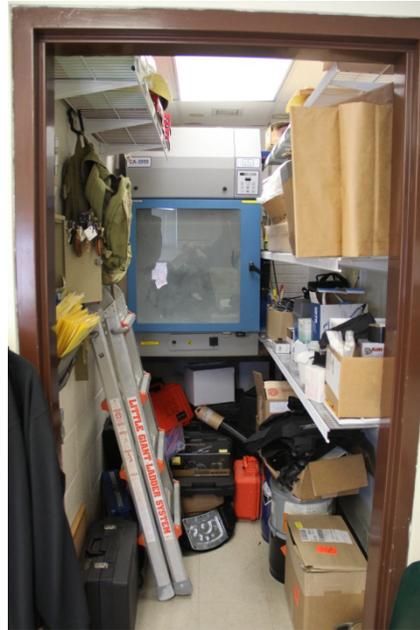
- Evidence areas are totally inadequate for a facility of this size and are minimally protected. These areas house numerous firearms, evidence that serious cases are based on, controlled substances and drugs. An evidence processing room and system to track all evidence in an organized manner is necessary to avoid compromising a case.

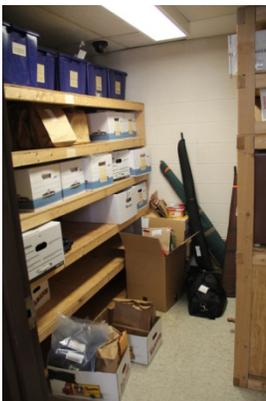
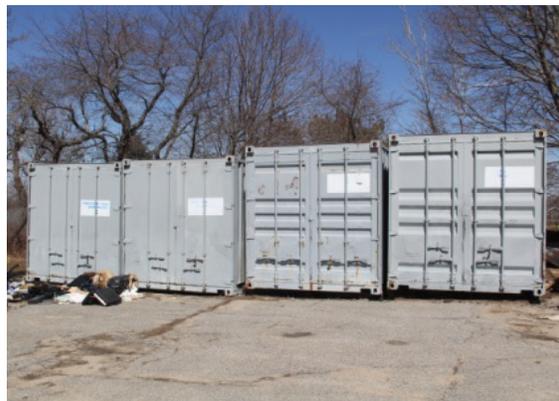
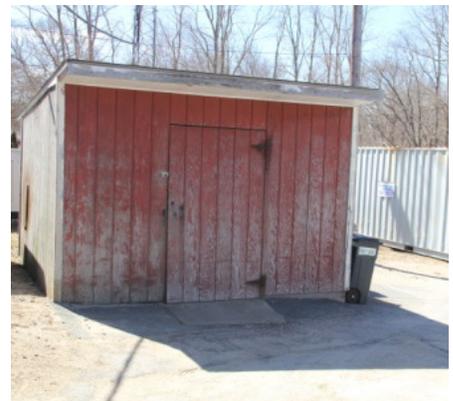
- There is inadequate evidence storage space. There is one "secure room" which has been over-loaded for years making working in the area difficult and time consuming. It also makes locating evidence much more difficult than is reasonable. Due to the room's small size, some evidence is stored in other spaces that are "unsecured", including storage bins behind the Fire Department. The current evidence storage space was originally a storage room converted to its current usage and is truly not "secure" due to the surrounding walls that terminate at the ceiling plane and do not extend to the underside of the structure above.

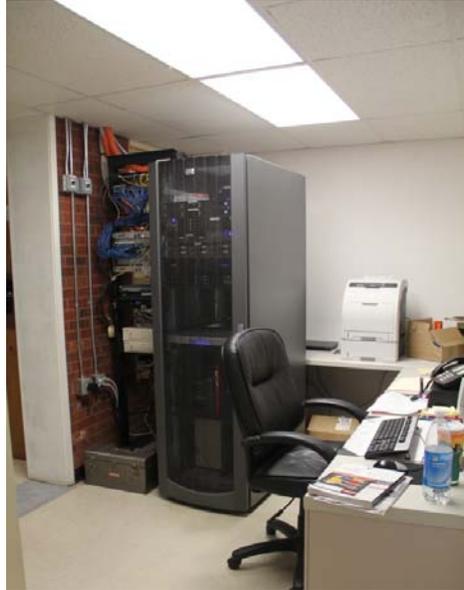
- The main components of the Police Department's computer system and records located in the Administrative Office are unprotected from easy access, tampering with or destruction thereof. The server generates heat and excess noise, thus requiring additional coding and rendering telephone conversations difficult, possibly leading to misinterpreted information.

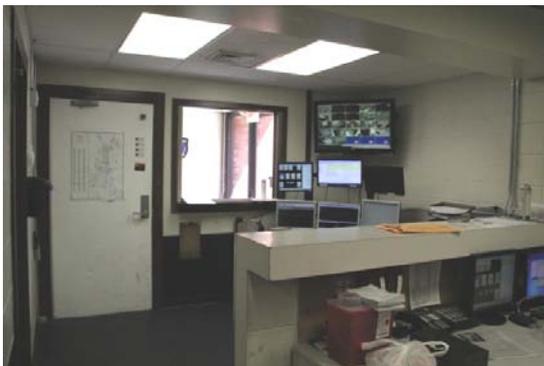
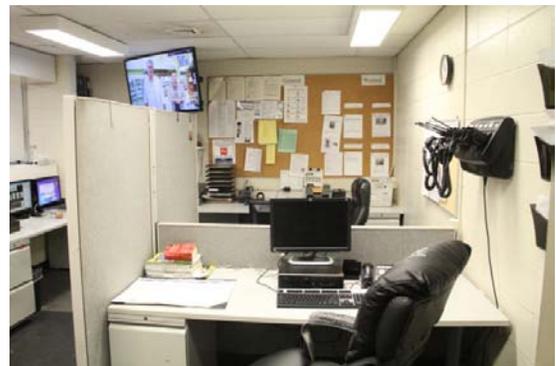
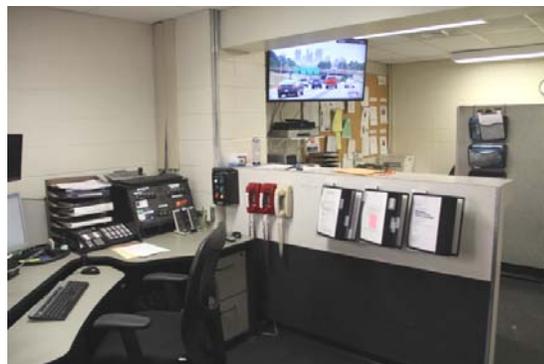
- The current Dispatch Center will need expansion and there is no room to do so. There is no space available for another dispatcher in the event of an emergency or if the dispatcher is extremely busy.

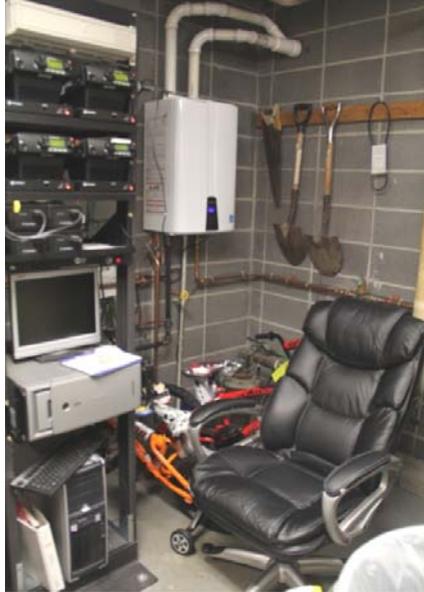
- The computer for radios is located immediately adjacent to the gas-fired hot water heater. The door to this room has been removed which would allow a fire to spread between it and the connecting Utility Room.

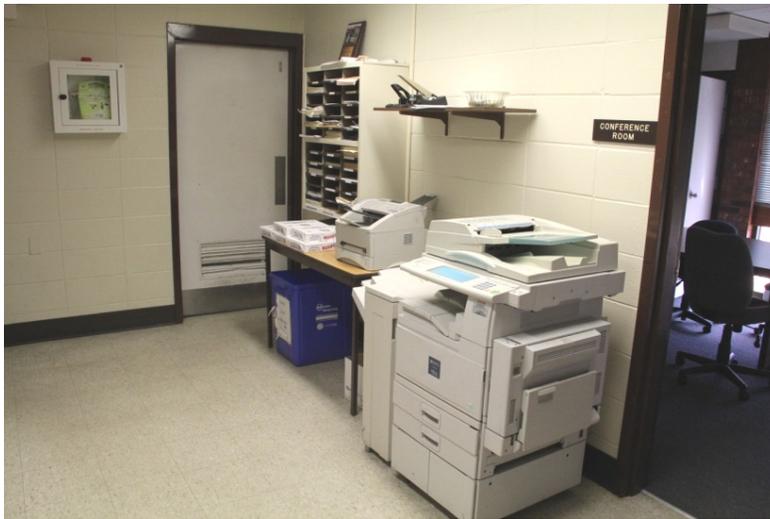
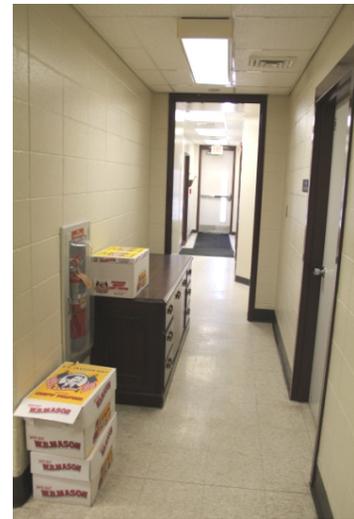
- The Dispatch Center does not currently meet NFPA standards and should be upgraded to do so.
- With new technology (E-911 service, computerization, etc.) the Dispatch area does not allow good access for wiring upgrades and the installation of new equipment without considerable disruption of operations.
- Electrical wiring and telephone lines in certain areas are hazardous and not supported using code-approved fasteners.
- Corridors are being used for copier, fax and scan equipment along with storage of supplies in violation of building and fire safety codes. In the event of an emergency, these items could impede the safe evacuation of the building. An unruly detainee could also cause considerable damage to the equipment.

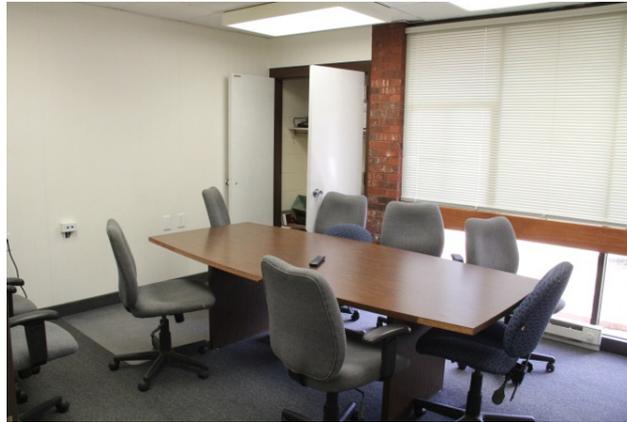
- Heat and cold fluctuations are a daily occurrence, which affects employee's ability to work comfortably. Entire sections of the building are on one zone causing some spaces to over-cool or over-heat while others are receiving the opposite effect. In several east-facing rooms with glazing extending to the floor, electric heat has been used to supplement the ineffective air system.

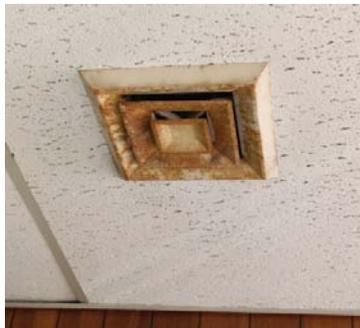
- Lack of ventilation in certain areas poses health risks. Areas such as the Evidence Room, Janitor and Photo Lab need better venting to the outside of the building. None of these areas have this at present. The dangers in the Evidence Room come from the storage of certain drugs which product spores. If inhaled, they can cause certain diseases in the employee.

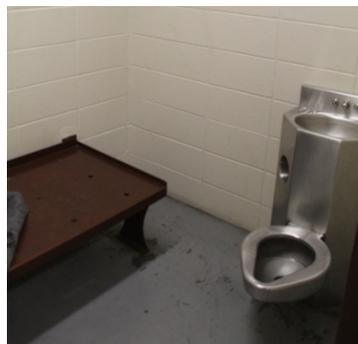
- Poor ventilation in the detention cells creates an odor problem (originating from prisoners) for staff that must access these areas on a regular basis to check on prisoners.

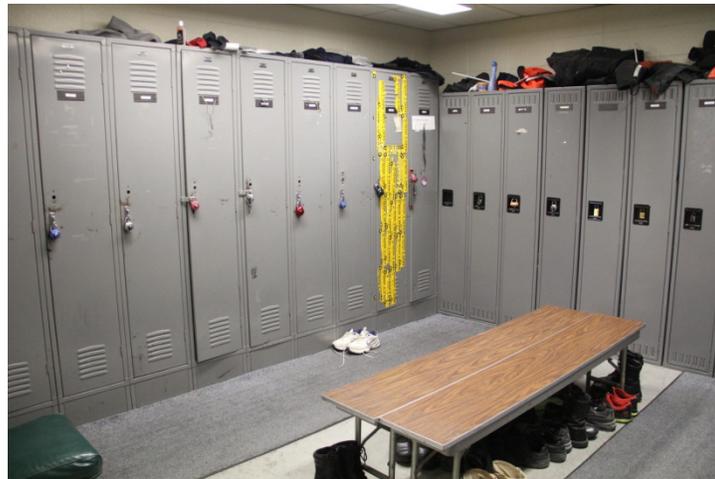
- Another area greatly suffering from a lack of ventilation is the Male Locker Room. The odor of the hot and humid environment makes the area less than desirable to use. It is also very crowded and does not provide adequate space for changing, or benches and storage in proportion to the number of lockers and equipment needing storage. The female locker room was converted from the former Deputy Chief's Office provide limited, private facilities.

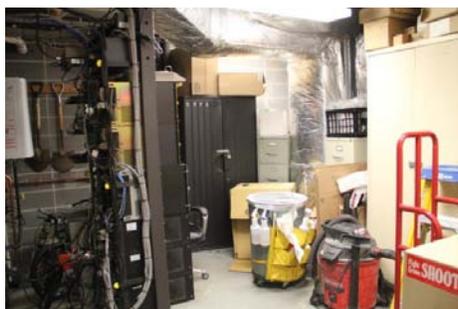
- There are no refrigerated evidence lockers to store safely evidence containing human blood, DNA or biohazard features.
- Access to wiring (electrical and telephone) and other utilities is both confusing and difficult due to all of the overlapping construction changes and added walls/rooms developed in previous attempts to better utilize the existing spaces.

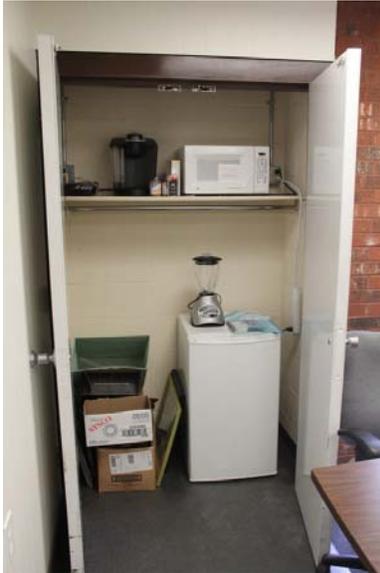
- The front public entry doors, toilets, locker room, detention and processing areas are not in compliance with ADA (American Disability Act) for persons with disabilities.
- The Conference Room serves as the employee lunch/break room and occasionally as another interview room. The small alcove housing an under counter refrigerator, coffee machine and microwave are inadequate in size for the number of staff utilizing these appliances.

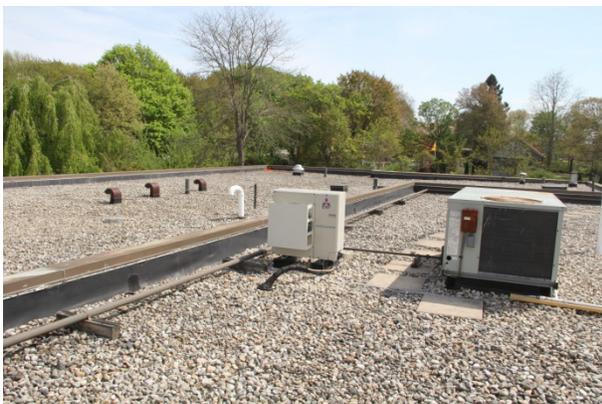
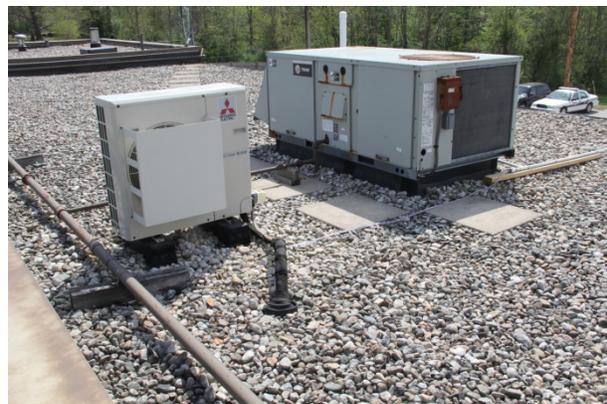
- On occasion the building has had an infestation of rodents requiring exterminators to eliminate the problem.
- Persistent roof leaks are the result of a loose laid stone ballasted EPDM (rubber) membrane that has lasted far beyond its 20 year life expectancy.

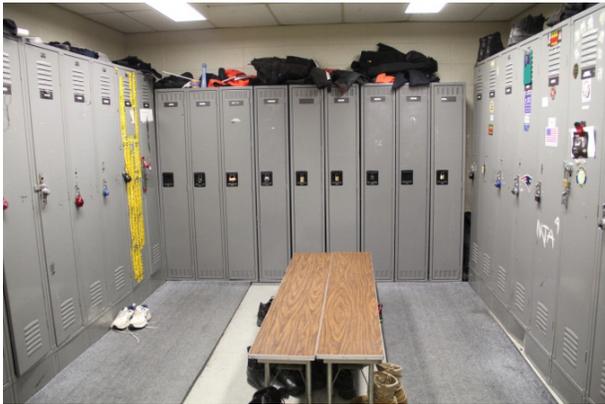
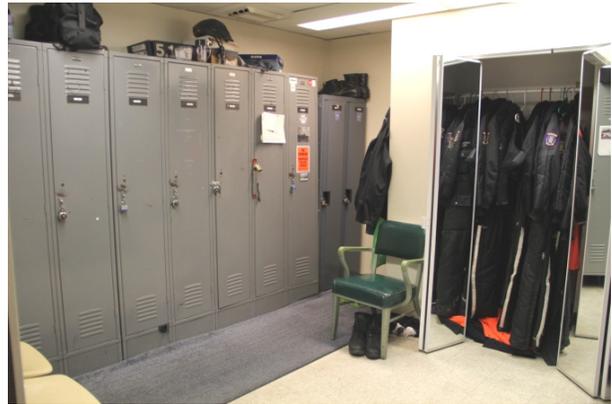
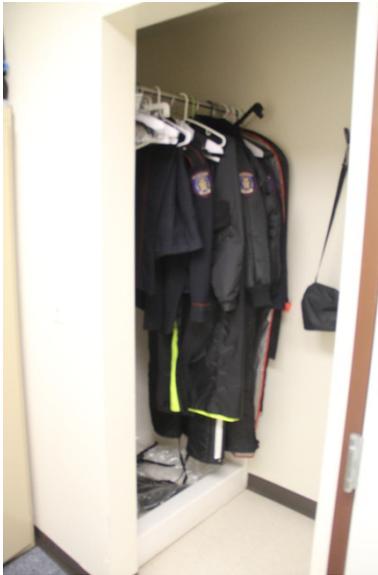
- Privacy issues are common. Any employee involved in a confidential or private conversation in any of the administrative or supervisory office can be both seen and easily heard by other employees, some of whom work just a few feet from the window, wall or door that separates the work spaces. This also pertains to phone conversations and the interview areas, which afford little privacy.
- Certain areas present a noise problem. Recording statements from small child victims becomes overpowered by noise generated from other parts of the building or people in adjacent rooms or corridors.
- The existing Male and Female Locker/Toilet/Shower Rooms are extremely overcrowded and provide minimal privacy between functional areas. This is especially true in the Female Locker Room where the only shower is being used to hand uniforms and foul-weather gear.
